The Garratt Family Farm
 "Argyle"
 Southbrook
 near Pittsworth, Queensland
 email.com.au

COMPOST PACK BEDDING COW SHELTERS

Narrow compost shelter with feedpad, open feed bunk and dry lot

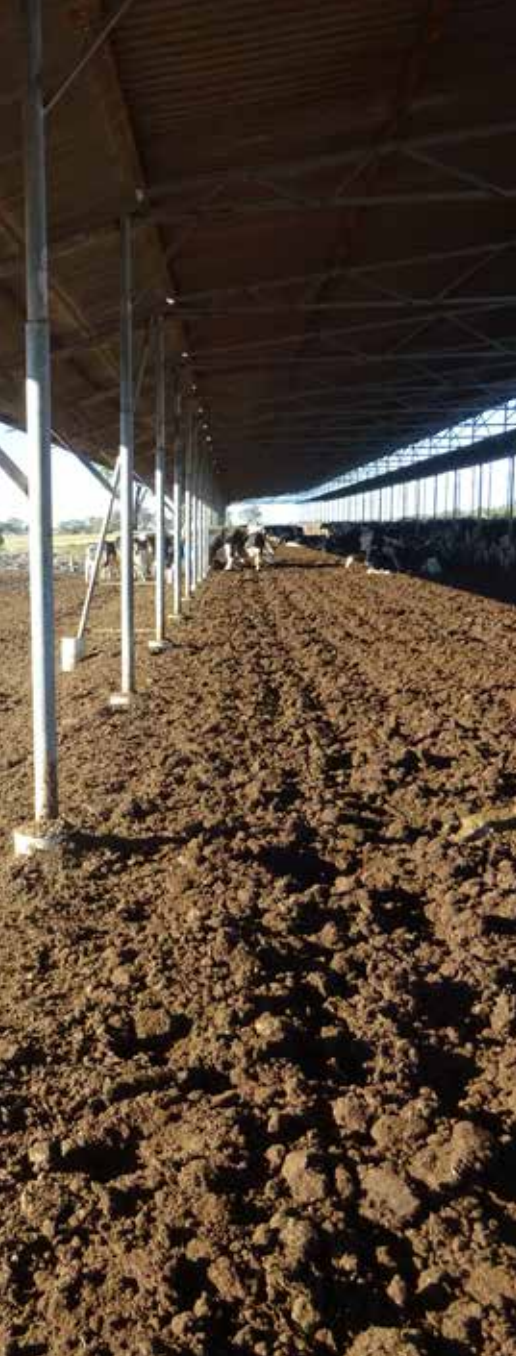
First to be constructed was the 160m x 5m concrete feed pad with skillion shade roof over the cow feeding alley built in a north-south orientation. The roof height is 3.6m at eave to 4.5m at the top. A gutter was fitted to pipe water away.

The second skillion roof shed was constructed two years ago, with a saw tooth design with first roof. Dimensions are 160m x 8m with a 160m x 2m awning to protect the pack from weather on eastern side. The floor is compacted earth/gravel with compost bedding approximately 300mm deep on top. Three water troughs are on eastern side with drain pipes to reticulate the waste water away from bedding.

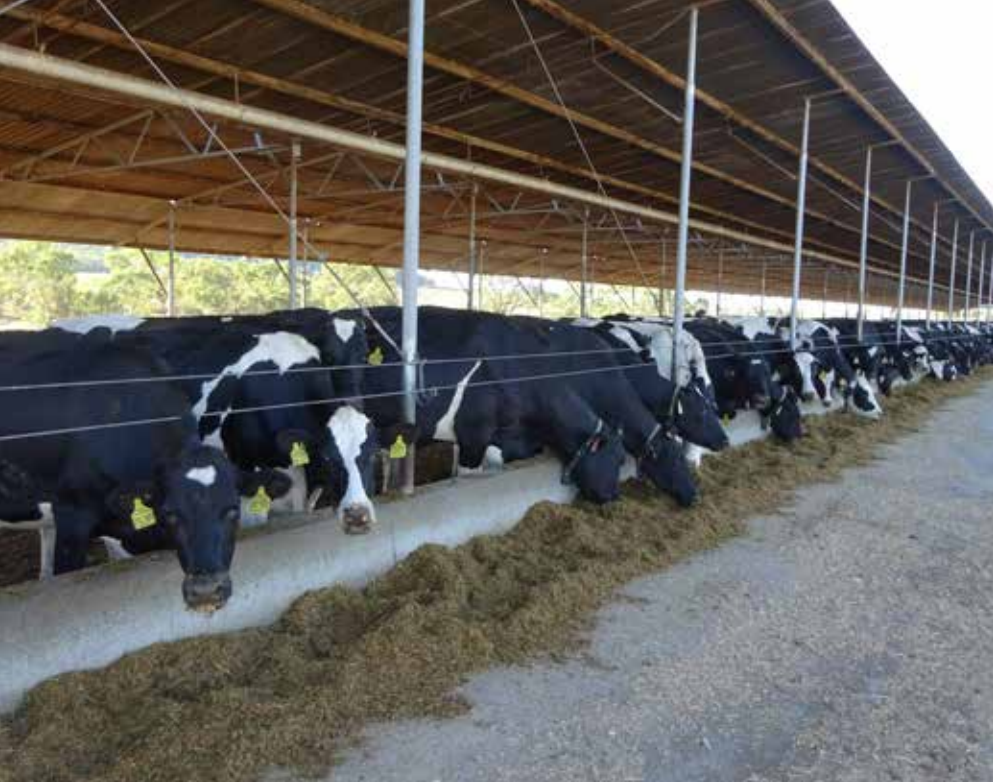
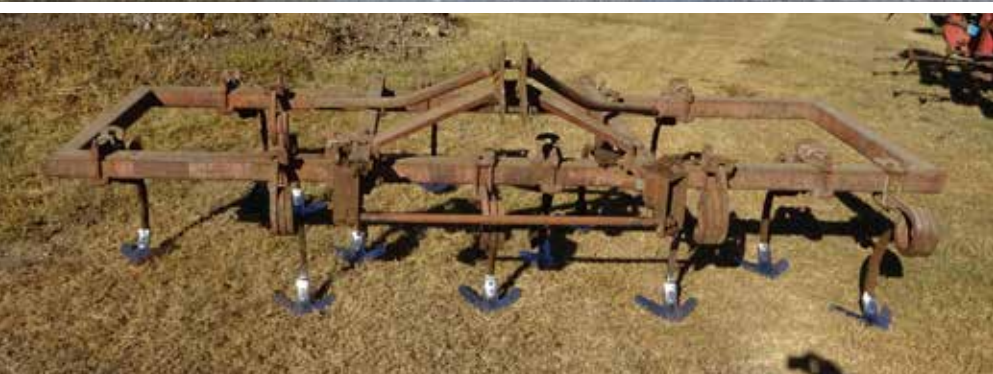
The compost shelter is used for the milking herd only, being utilised full time in summer and hot weather

The compost shelter is used for the milking herd only, being utilised full time in summer and hot weather (Christmas to mid-May), when using TMR. In winter, the cows graze ryegrass and get PMR daily and use the compost bed at night. If the weather is very wet, then the cows will use the compost bed full-time, with TMR.

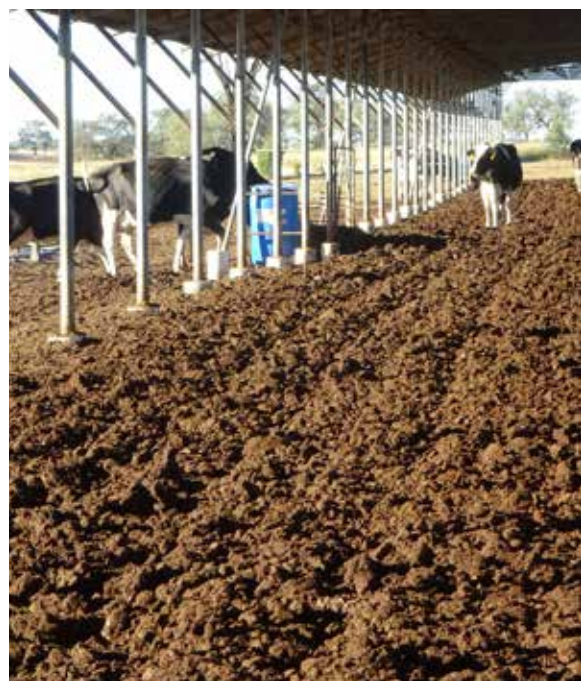
Peter thinks that the cows are very comfortable and use all the bed evenly. Sometimes they go outside onto the dry lot at night when the weather is hot.

Peter thinks that the cows are very comfortable and use all the bed evenly. Sometimes they go outside onto the dry lot at night when the weather is hot.
