Freestall – with sand bedding

Mark and Kate Walpole – Yielima, Northern Victoria

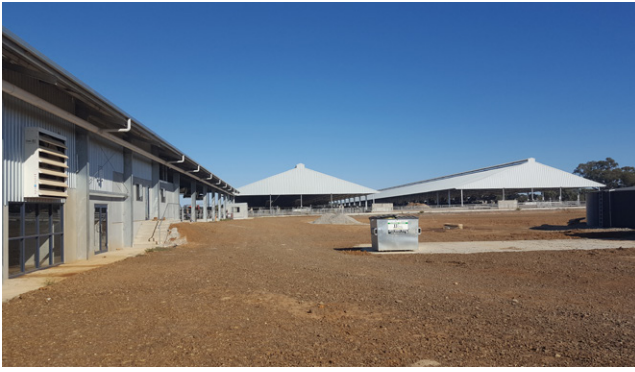
These widespan structures feature an open-web truss, portal frame, and a corrugated iron roof with an 18° pitch. Concrete drive alleys, 5m wide, and feed alleys, 4m wide, run along each side of the building under the roofline. The cow/feed barrier consists of post and rail with sprays to cool cows during hot weather while eating. In the center of the building, three double rows of stalls are designed to accommodate cows weighing approximately 650kg (1,200mm wide) using a conventional design with adjustable rails and no brisket board. Above each double row of stalls, there are large, energy-efficient, magnetic-driven fans (43 in total). Temperature sensors automate the sprays and fans.

Above the platform, four large fans deliver the cooled air onto the cows during milking, and the air is then released over the holding yard.

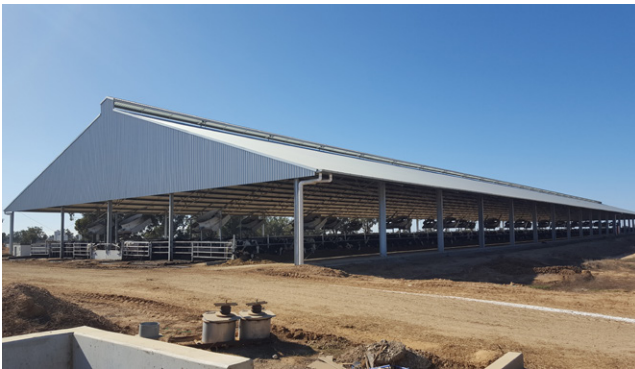
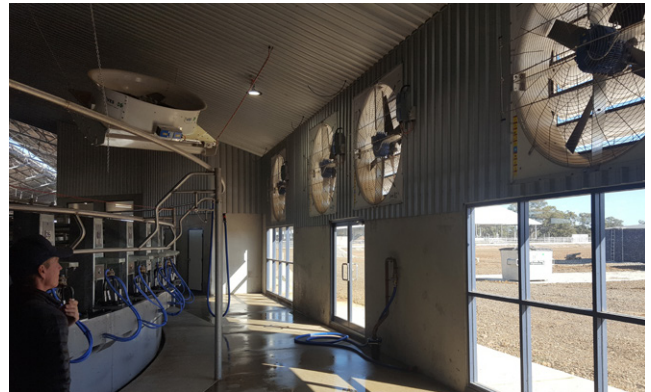
The dairy holding yard, which is 70m long and 13m wide, is equipped with wobbler sprinklers and 34 fans on automatic controllers to keep cows cool and control flies. Rubber flooring is installed in the high traffic areas, particularly near the platform and down the exit race. The goal is to milk cows in groups of 500, ensuring that they spend no more than 60 minutes in the yard during each milking.

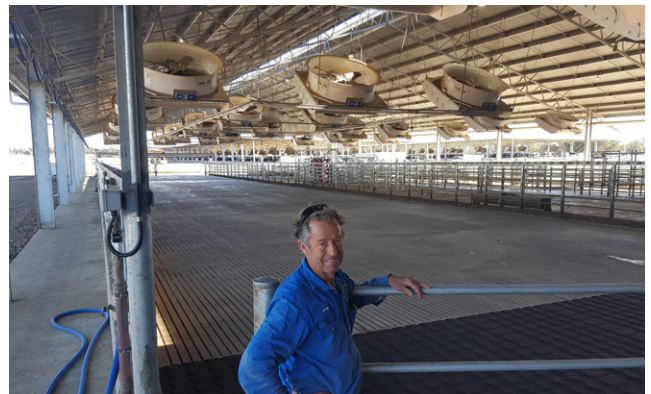
The new dairy parlour features an 80-stand rotary platform accessible from a roofed holding yard on the west side. Milk meters measure each cow's milk yield and conductivity. Herd testing every two months provides additional data on milk fat and protein concentrations as well as cell count. The parlour is enclosed on three sides and equipped with large, energy-efficient, variable-speed magnetic-driven fans on the north and south sides. These fans draw air into the parlour through misters, which operate in hot weather to provide evaporative cooling.

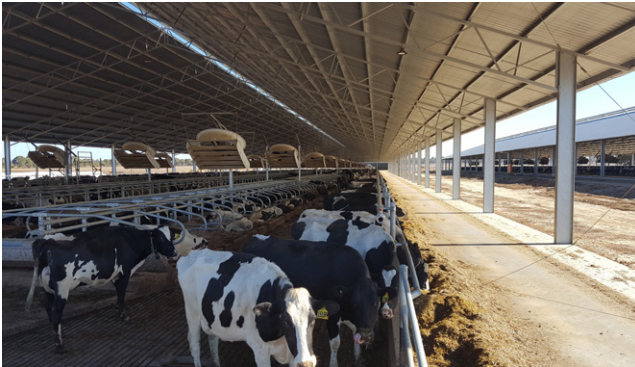
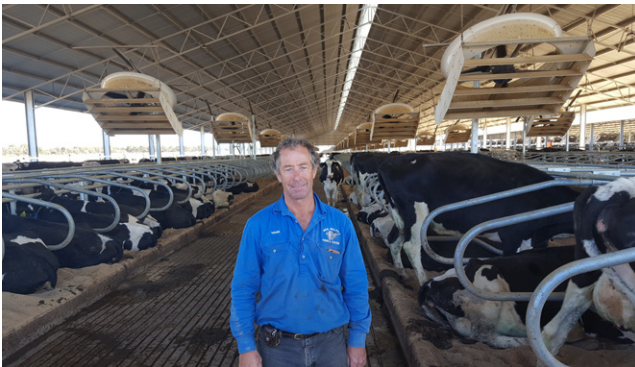
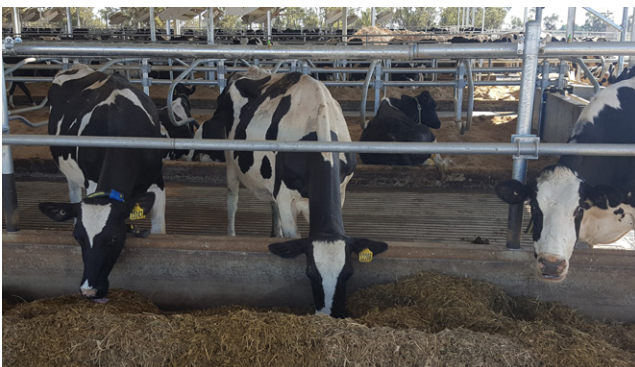
These cows adapted more easily to the new rotary platform compared to subsequent groups of cows transferred from the Walpoles' home farm, which utilised a rotary dairy spinning in the opposite direction. Mark noted that as the cows approached the bail, they instinctively looked for it to come from the right-hand side, but it was coming from the left. Currently, both freestalls are fully occupied, accommodating 1,000 cows each. One freestall houses the early lactation cow group and first-calvers, while the other freestall accommodates two mid-late lactation groups.

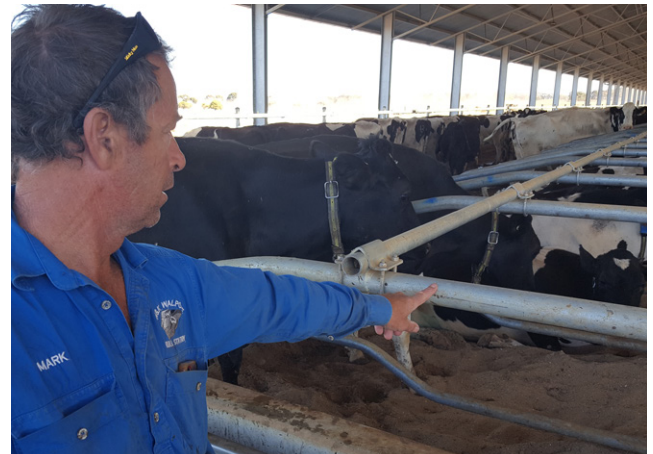
Feed is mixed and delivered along each drive alley once in the morning, between 3:00am and 10:00am, and pushed up four times per day. Water troughs are emptied and scrubbed daily when cows leave the freestall for milking. The cows and staff are provided with full light for 16 hours per day to ensure comfort and safety. Adjustments were made to the position of the head rail in each stall, as some cows were lunging too far forward. Only six cows have had difficulty adapting to the stalls and were subsequently returned to the home farm. Mark is pleased with the small number of cows standing in the stall alleys, indicating overall cow comfort in the freestalls.

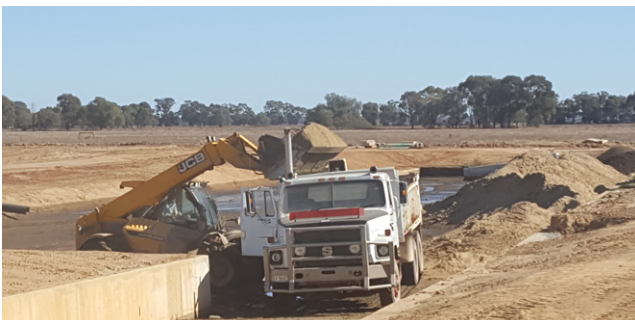
Due to a delay in fitting the screen in the manure solid/liquid separator, slurry filled the first two separation ponds during the initial weeks of operation and had to be removed. However, the separator is now functioning as intended, producing a stream of pressed manure fiber with a dry matter content of 30 per cent. This fiber is conveyed up a belt and deposited on top of a stack. Periodically, it is then removed from the stack and spread over the paddocks as fertiliser.
